Durability & Treatment

DATA SHEET

Durability and Treatment - Serviceability / Durability / Design Life of TimberLab Glulam

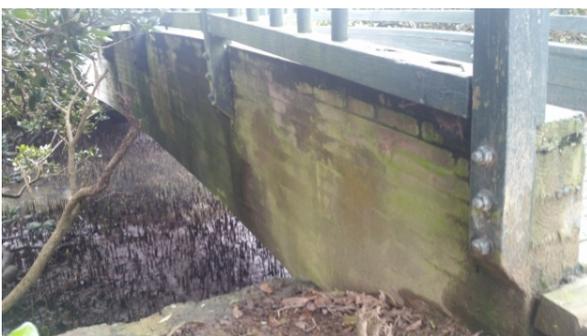
40-year-old bridge in treated Glulam. Situated in mangrove swamp subject to moisture and direct weathering.

No signs of any significant deterioration.

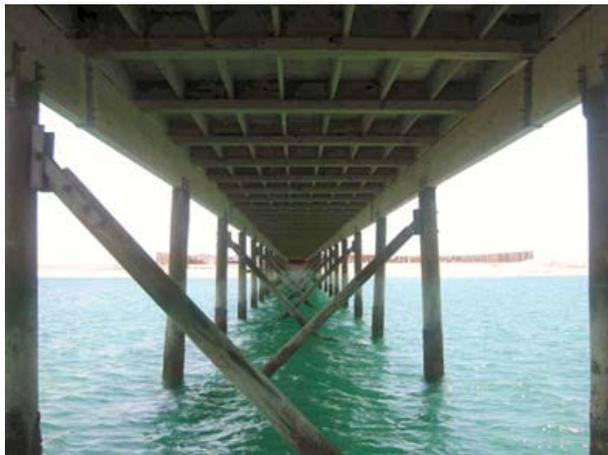
Treated TimberLab Glulam Beams on Treated Timber Poles Support 200m Jetty

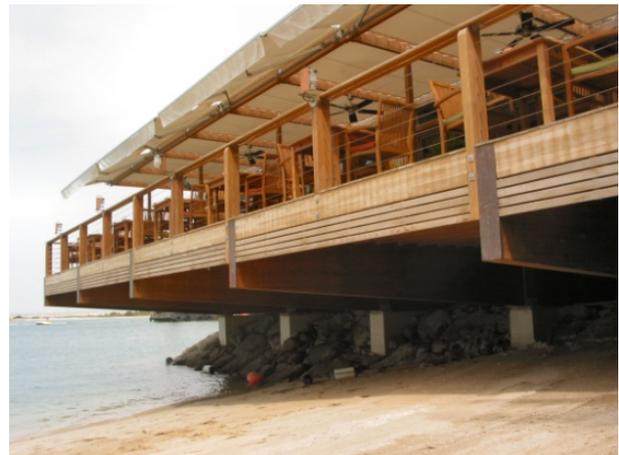
Cantilevered over seawater; treated Glulam beams support over water restaurant.
